CULTURAL RESOURCES SURVEY OF
THE SCE&G SALUDA DAM COMPLEX,
LEXINGTON COUNTY, SOUTH CAROLINA

CHICORA RESEARCH CONTRIBUTION 306

Prepared By:
Michael Trinkley, Ph.D.

January 8, 2001

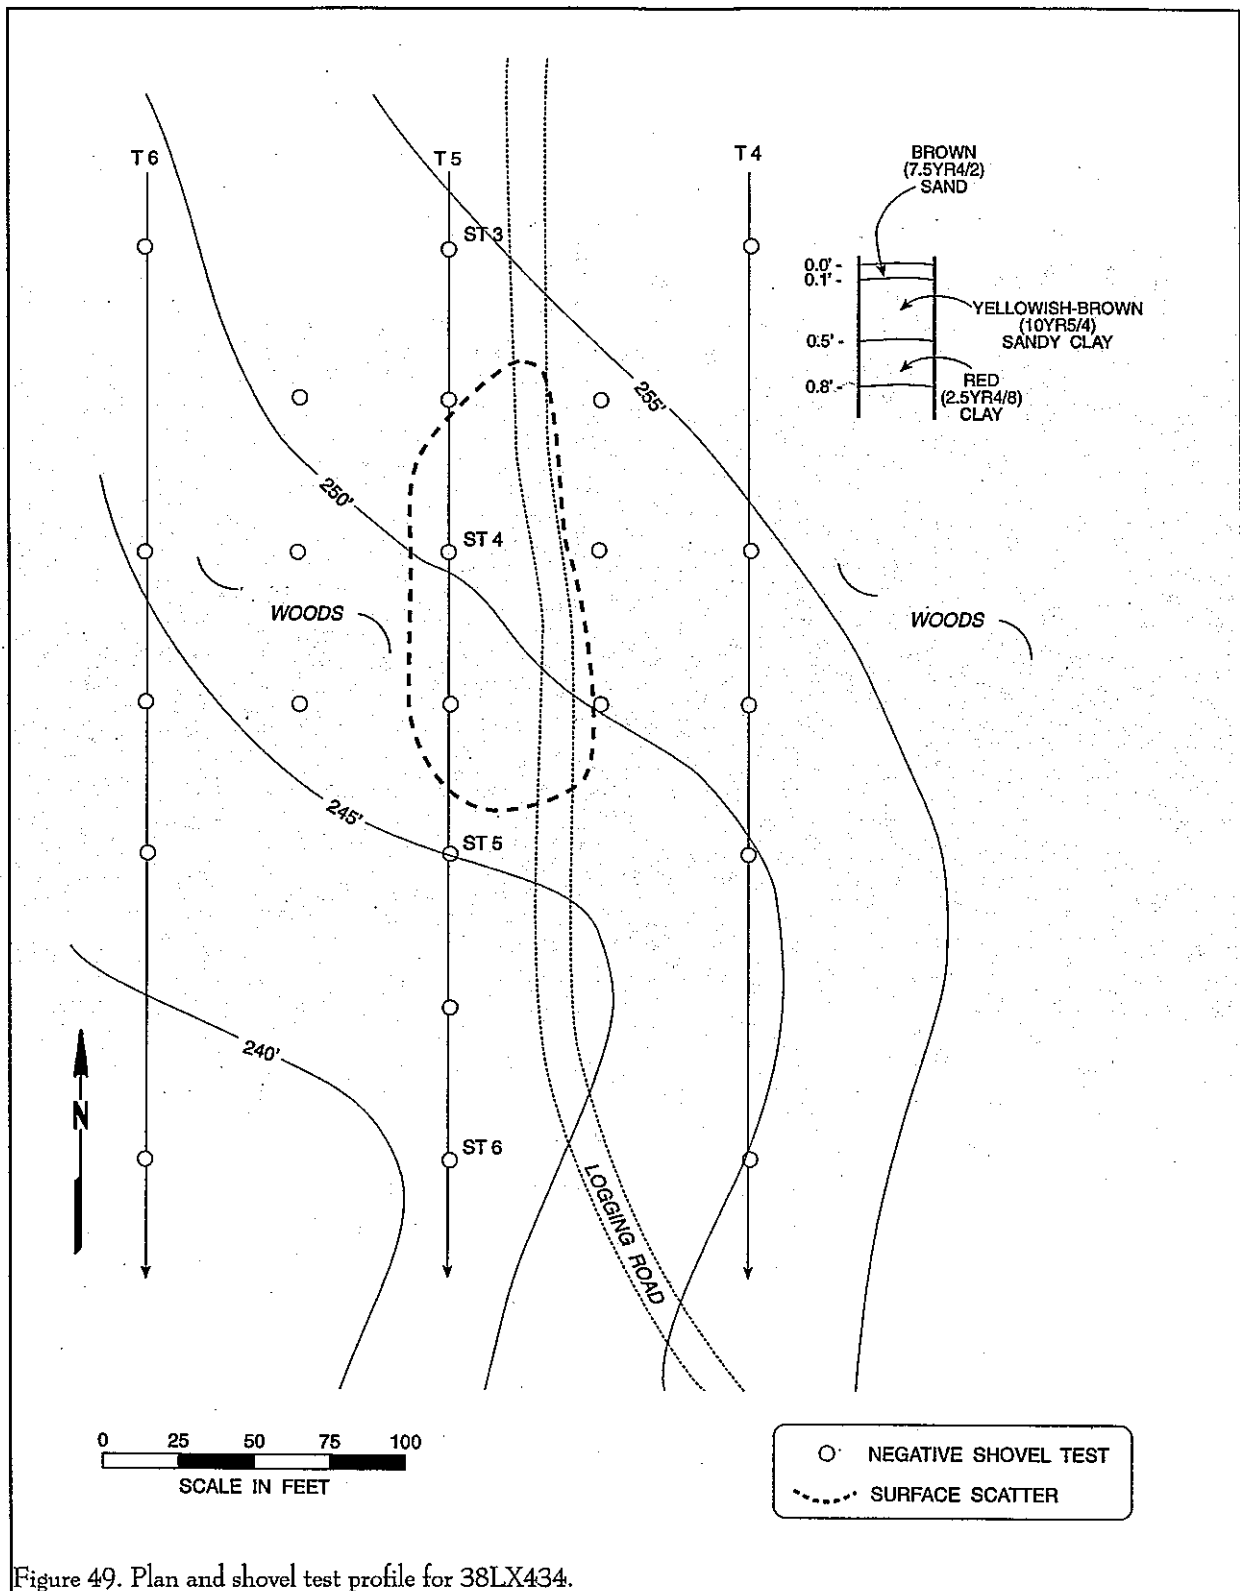
Figure 49. Plan and shovel test profile for 38LX434.

Site 38LX434 is a historic refuse scatter measuring 140 feet north-south by 60 feet east-west, yielding an scatter of about 8,400 feet² (Figure 49).

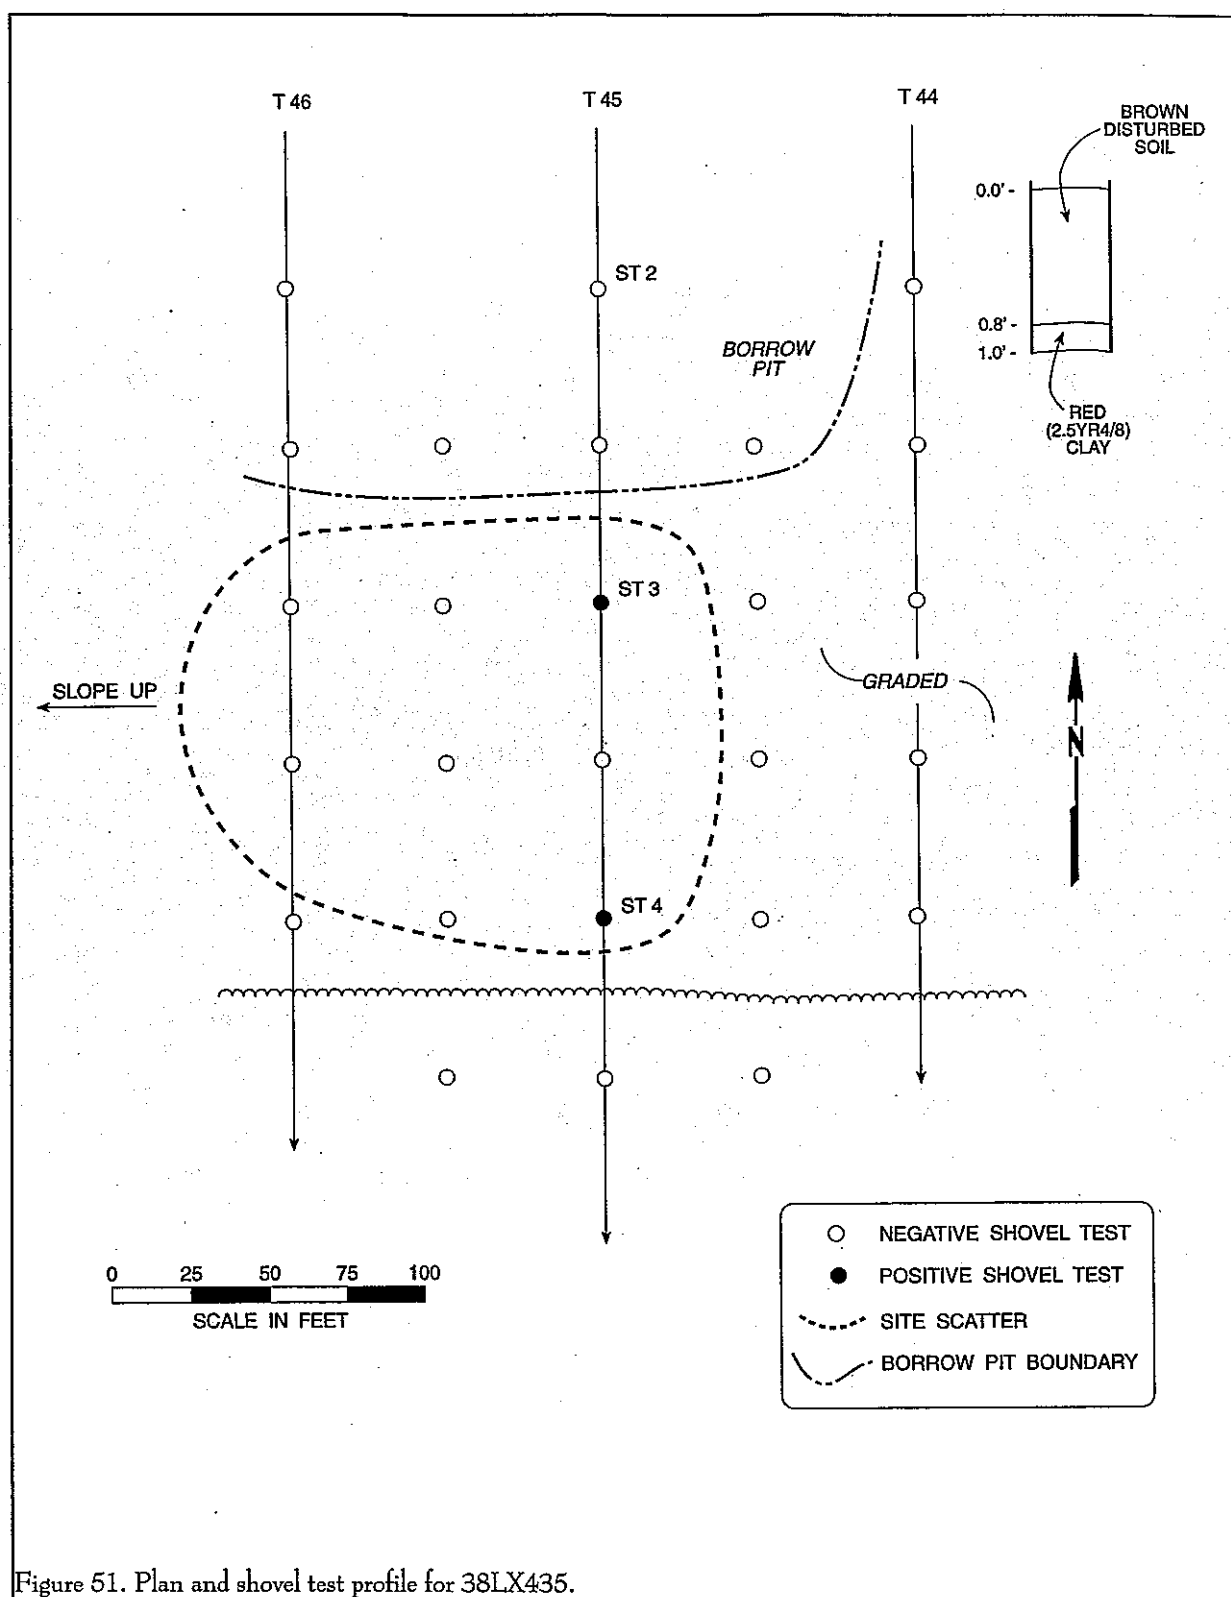
Figure 51. Plan and shovel test profile for 38LX435.

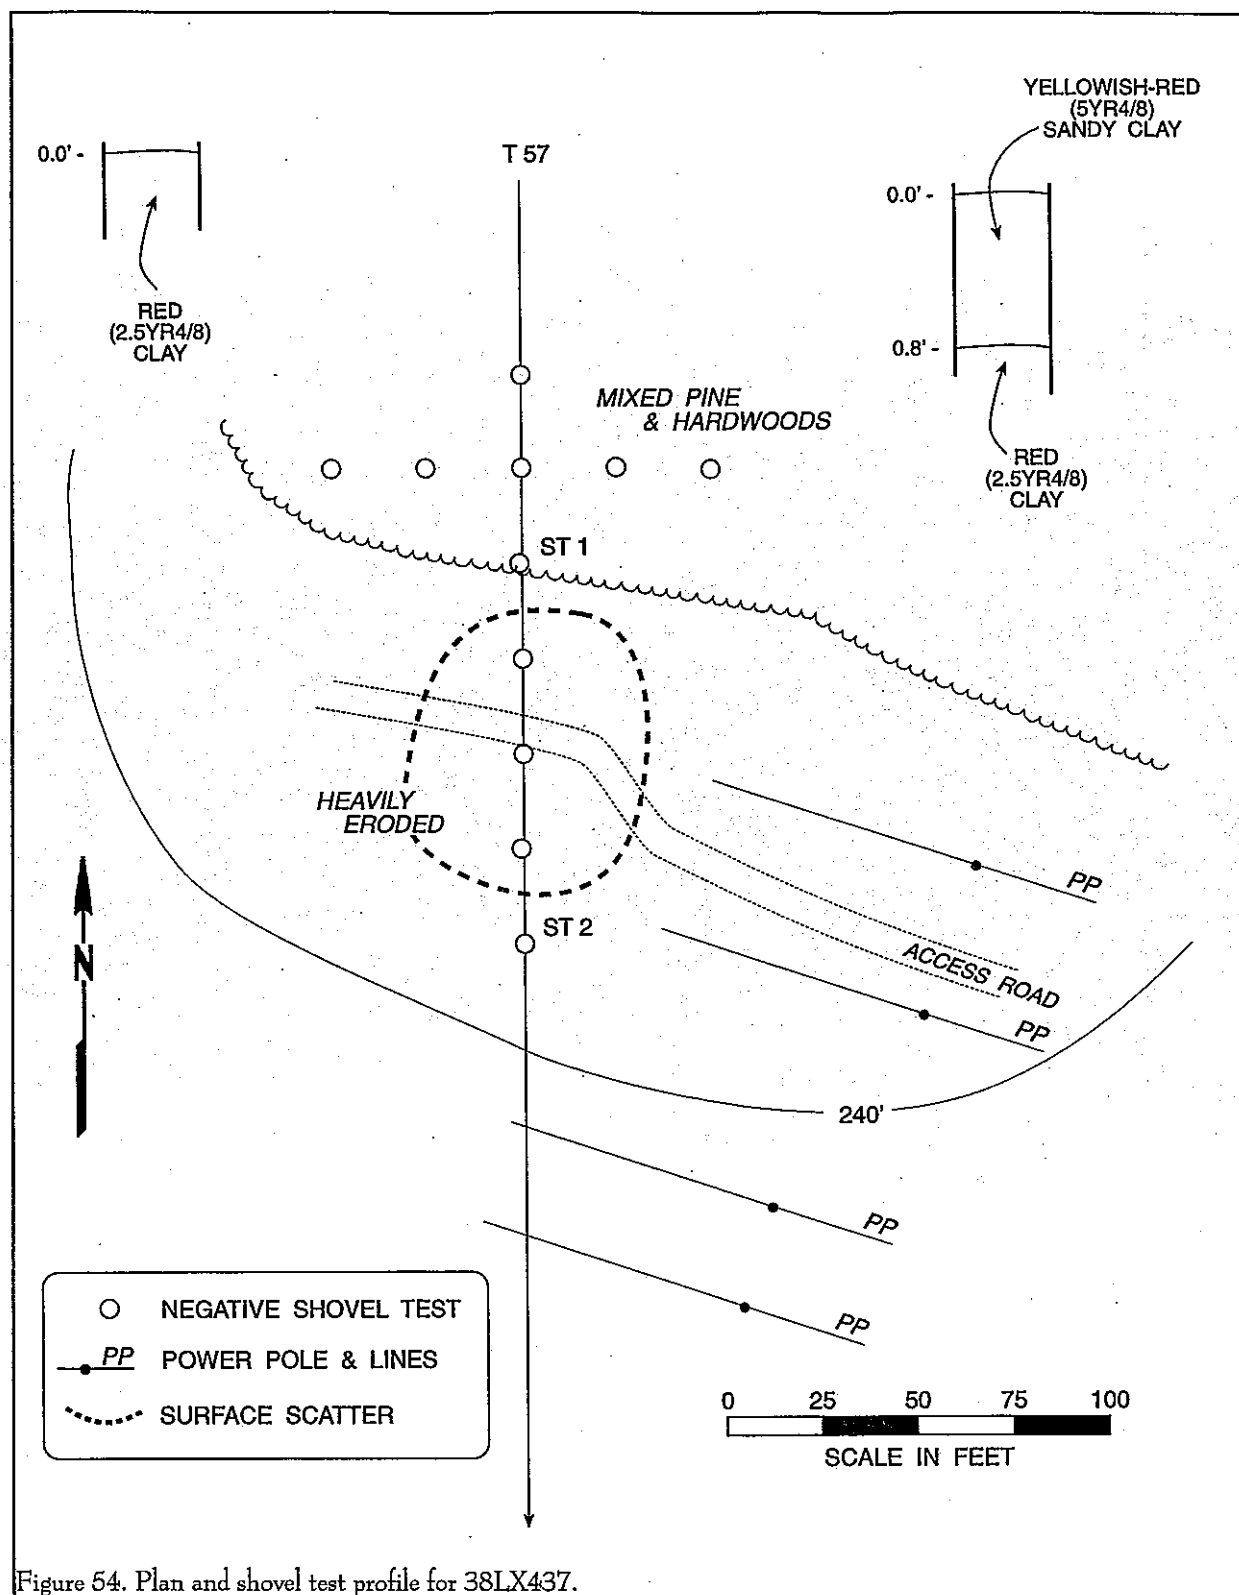
Figure 54. Plan and shovel test profile for 38LX437.

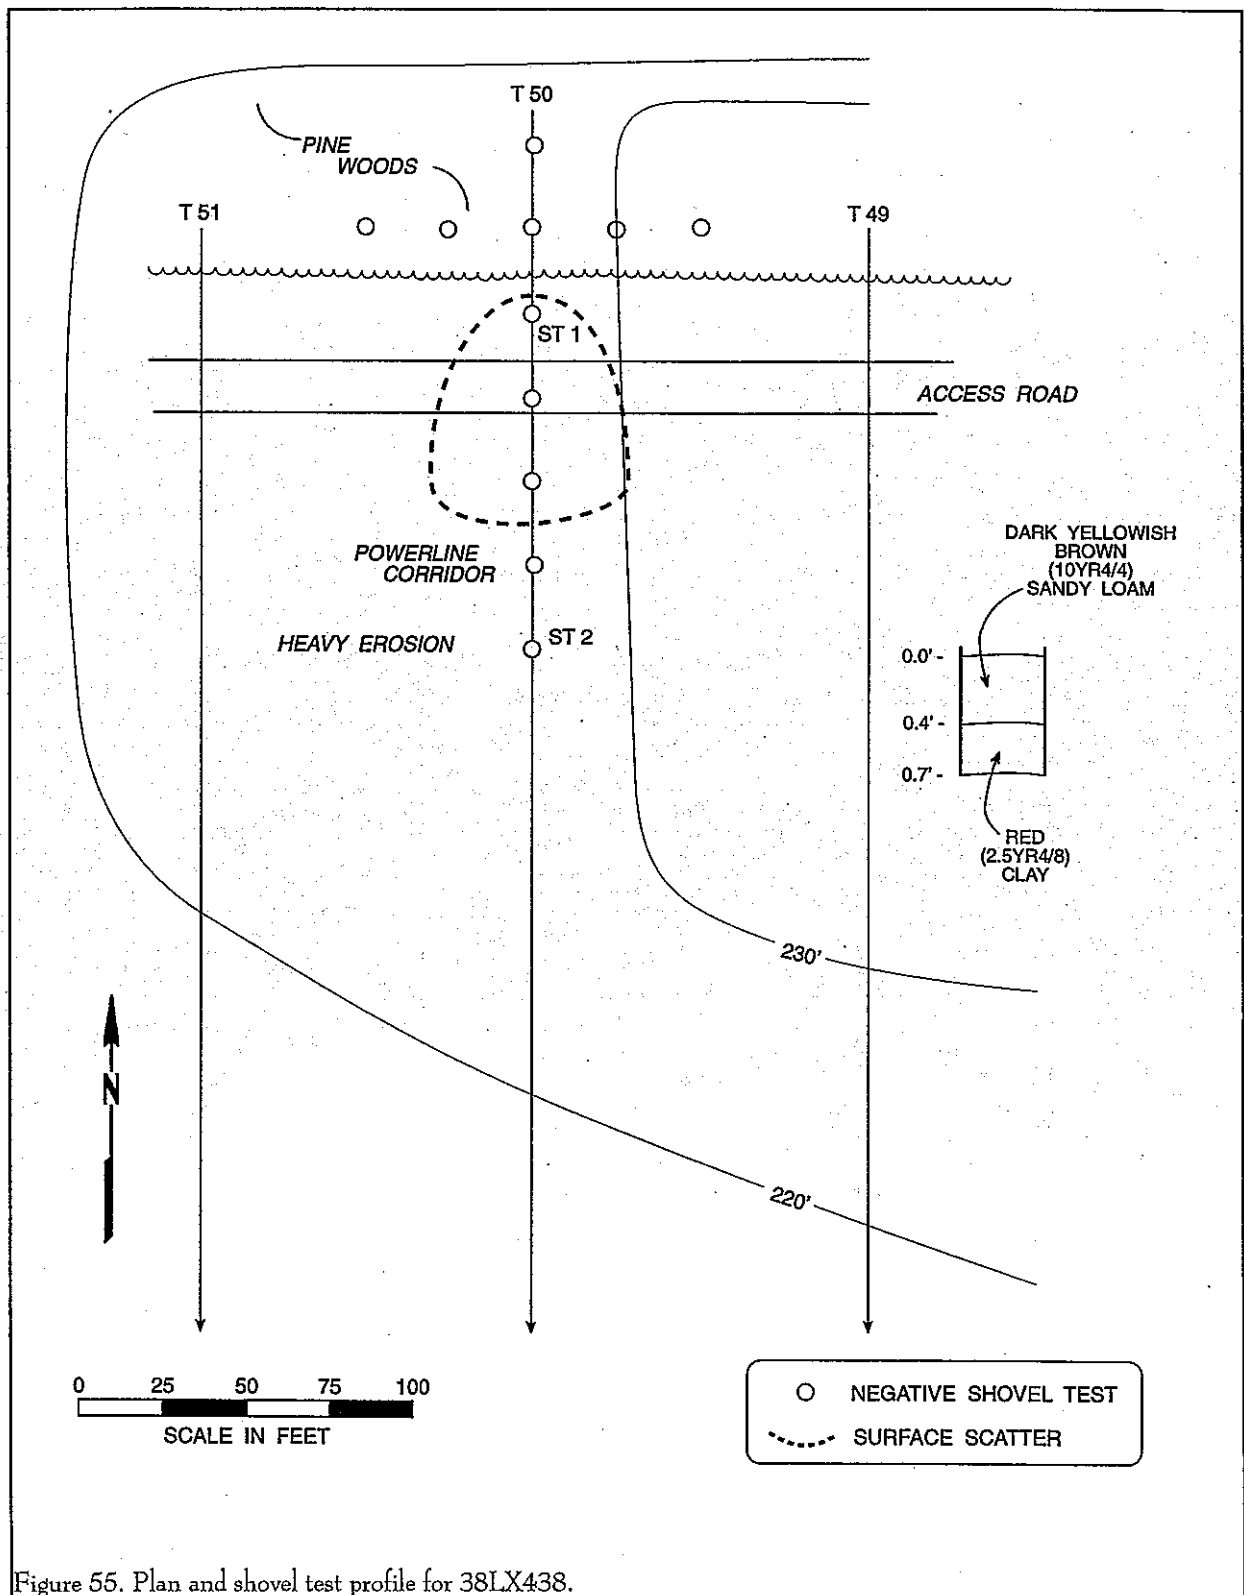
Figure 55. Plan and shovel test profile for 38LX438.

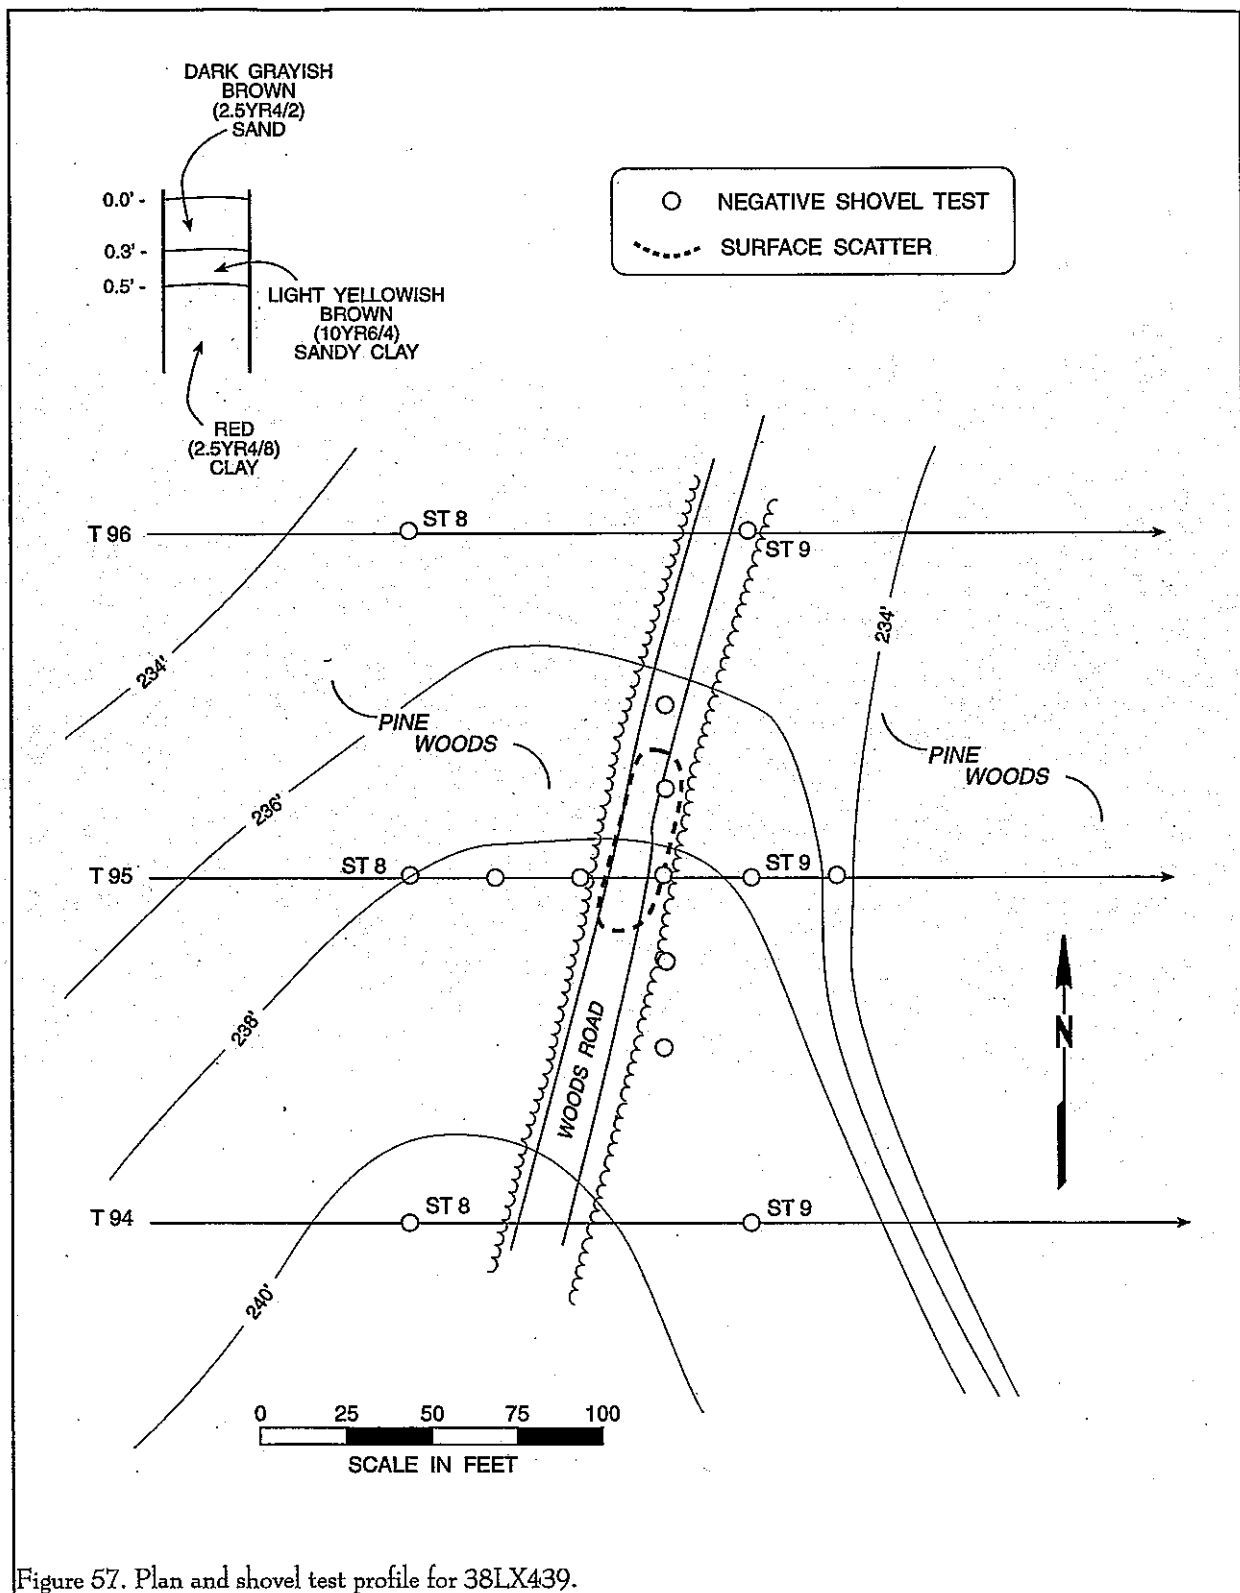
Figure 57. Plan and shovel test profile for 38LX439.

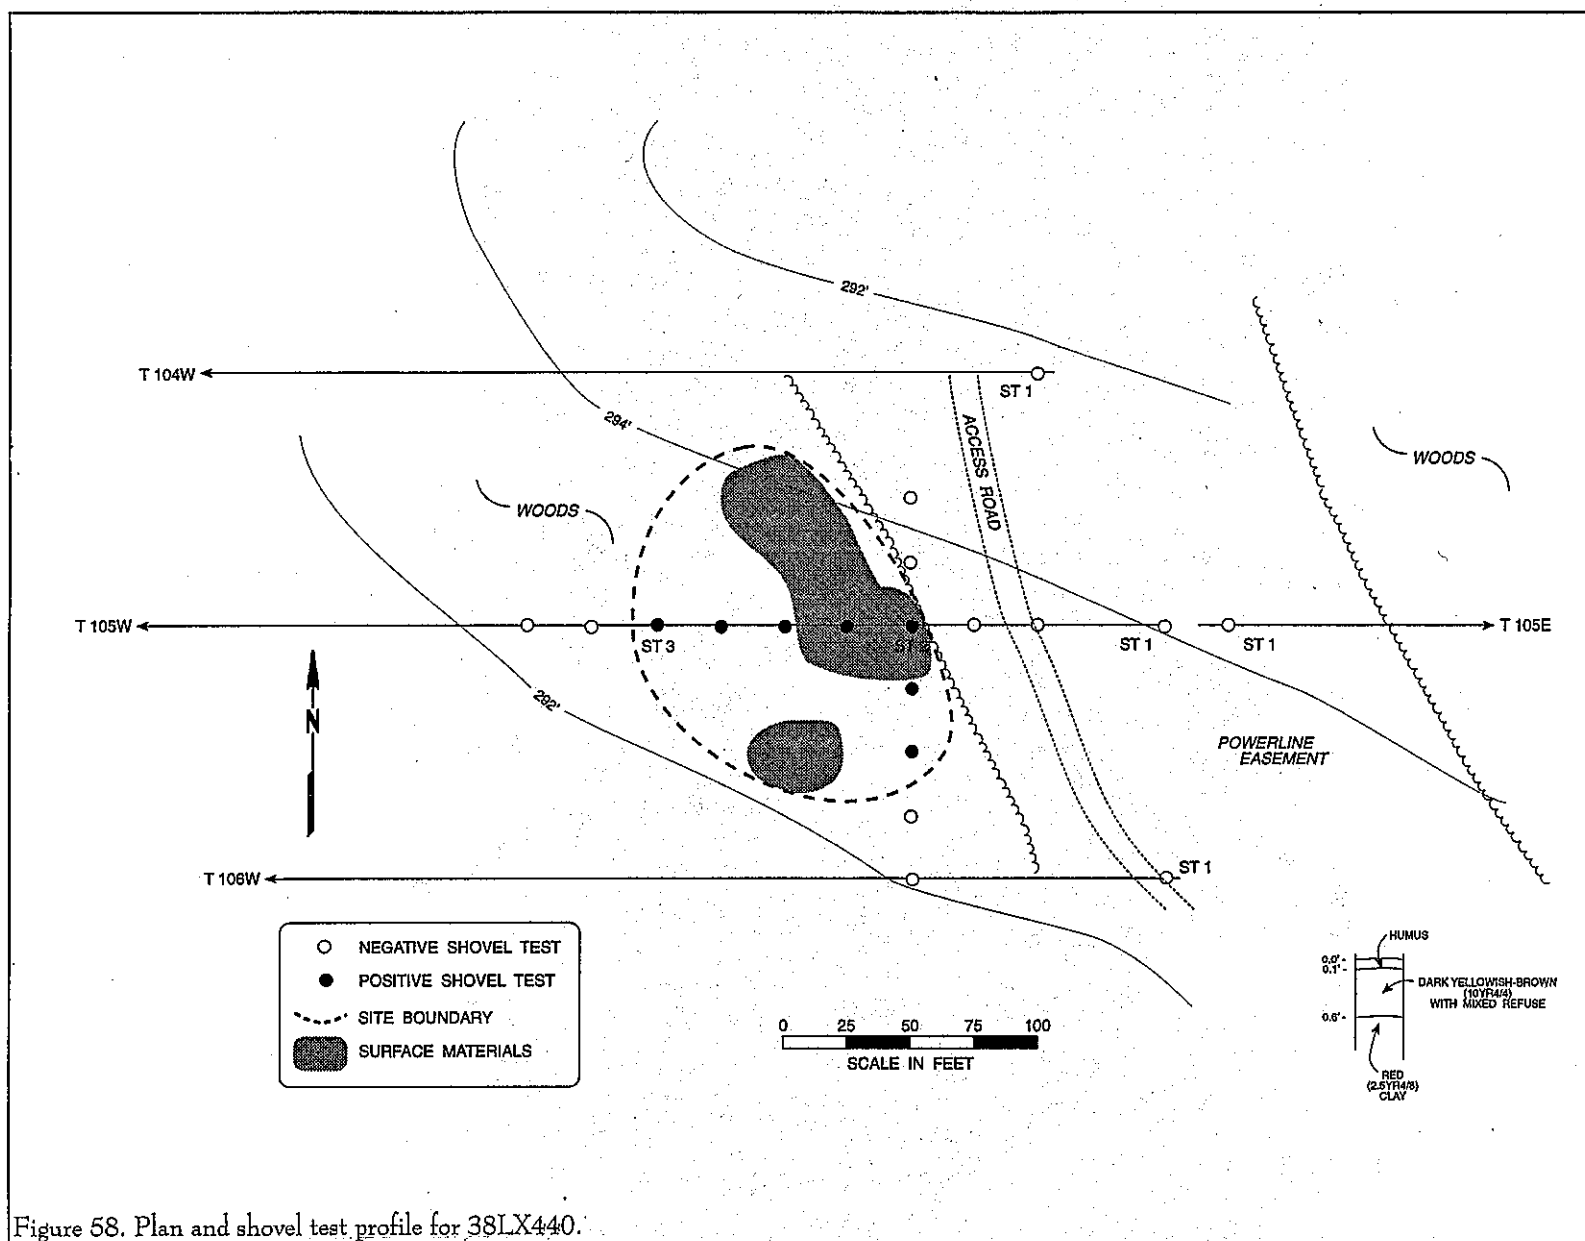
Figure 58. Plan and shovel test profile for 38LX440.

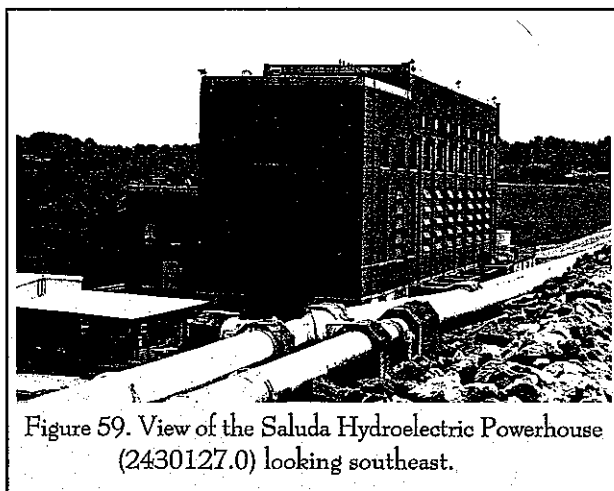
Figure 59. View of the Saluda Hydroelectric Powerhouse (2430127.0) looking southeast.

Of the 11 resources on the survey tract, all but three represent extant components of the Saluda dam, Saluda Hydroelectric facility, or McMeekin plant. Site 2430127.0 is the dam and Saluda Hydroelectric Powerhouse. As previously discussed, the dam was built between September 1927 and September 1930, with the formal completion occurring in December 1930. The powerhouse, of steel, brick, and concrete construction, measures 250 feet in length, 57 feet in width, and 100 feet high. It contains metal sash projecting windows on the dam (west) facade and a series of five roll-up metal doors on the downstream (east) facade; one at grade and four to allow the transformers to be moved inside the structure for maintenance work. The walls are laid up in 5/1 American bond with concrete medallions and roof parapet. The roof itself consists of a flat concrete deck with membrane roofing.

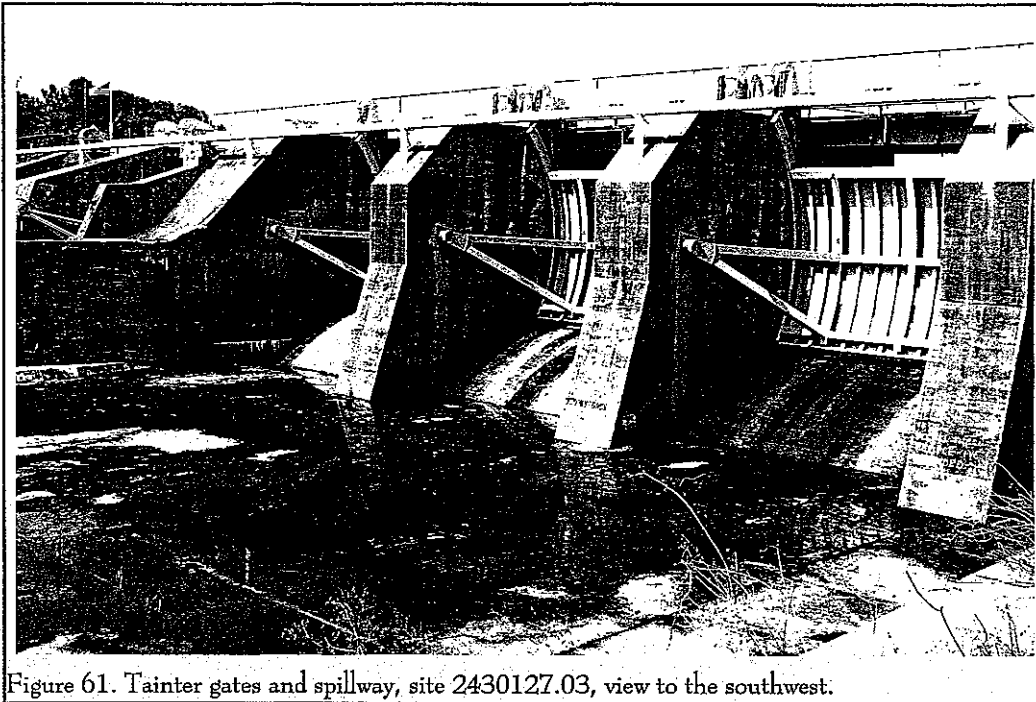
Figure 61. Tainter gates and spillway, site 2430127.03, view to the southwest.

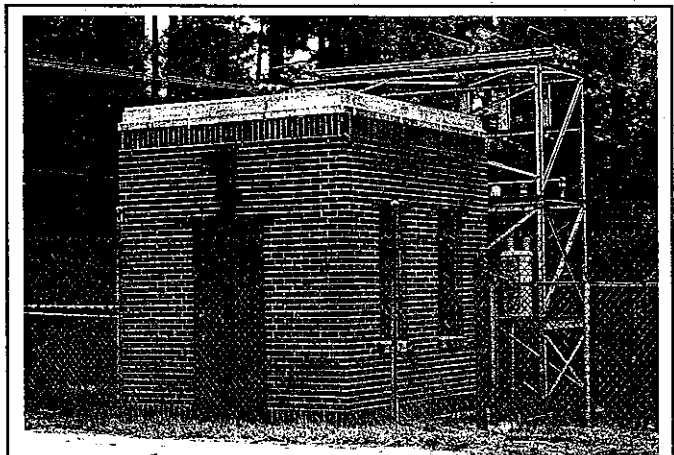
Figure 62. Switching house at the spillway (2430127.004), view to the northeast.

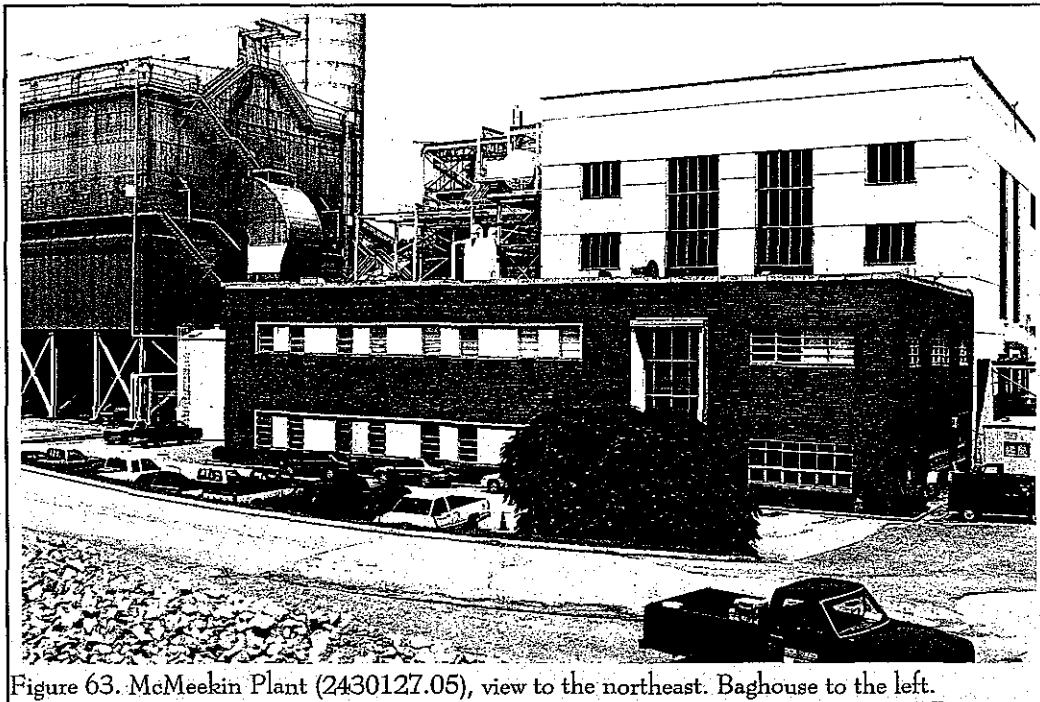
Figure 63. McMeekin Plant (2430127.05), view to the northeast. Baghouse to the left.

Site 2430127.05 is the McMeekin Fossil Fuel Steam Generating Plant, constructed between 1956 and 1958, and altered in ca. 1985 with the addition of Bag Houses 1 and 2 on the north facade. The main building, on a concrete slab foundation, has

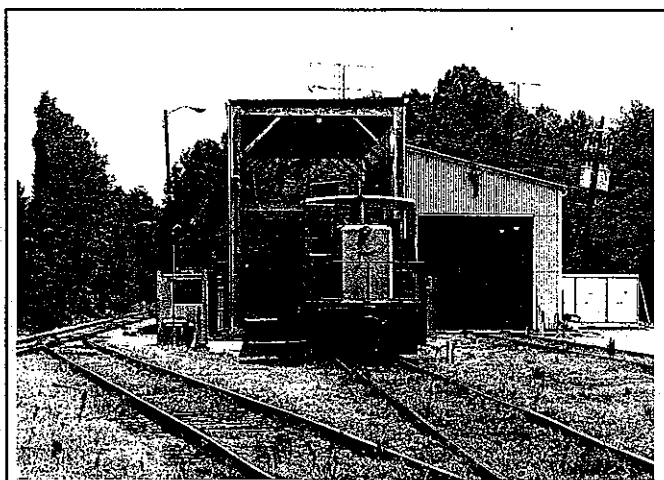
Figure 64. McMeekin Track Hopper House (2430127.06), view to the south.
